PORTLAND HARBOR PROPOSAL PLAN COMMENTS

SILTRONIC CORPORATION

PREPARED FOR
SILTRONIC CORPORATION
SEPTEMBER 6, 2016
PROJECT NO. 8128.02.03

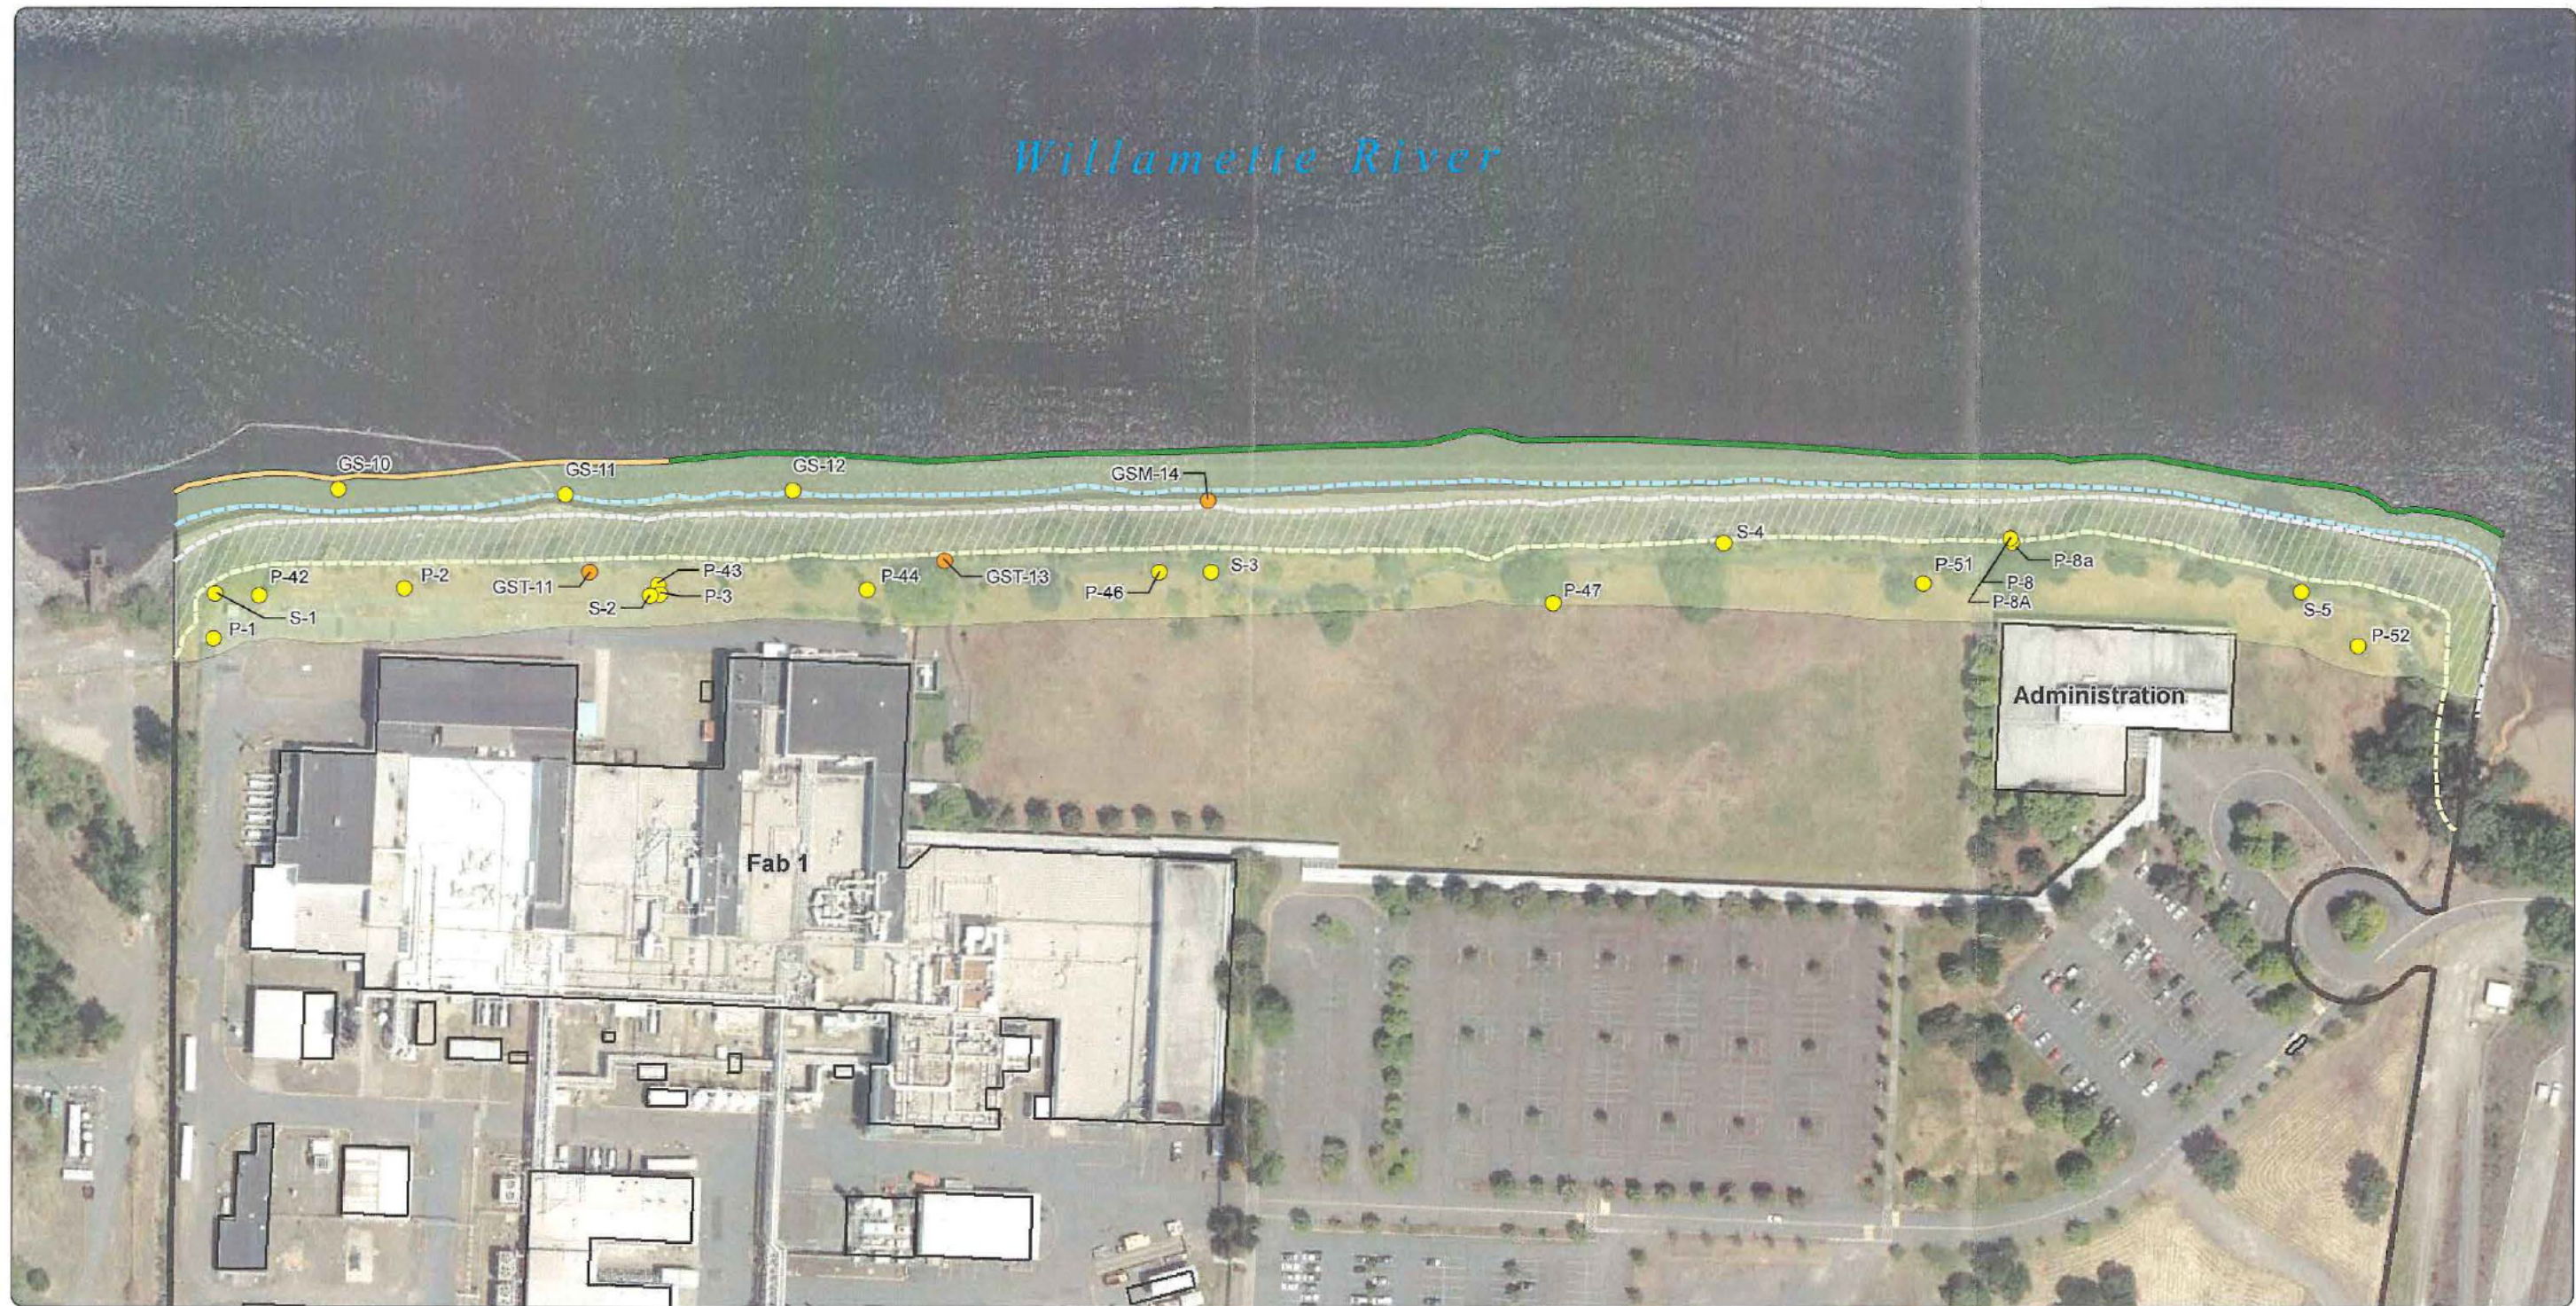
Figure 1
Riverbank Surface Soil Sample Locations
Siltronic Corporation
Portland, Oregon

Notes:
1. Top of Bank, Toe of Slope, and Ordinary Low Water locations are approximate.

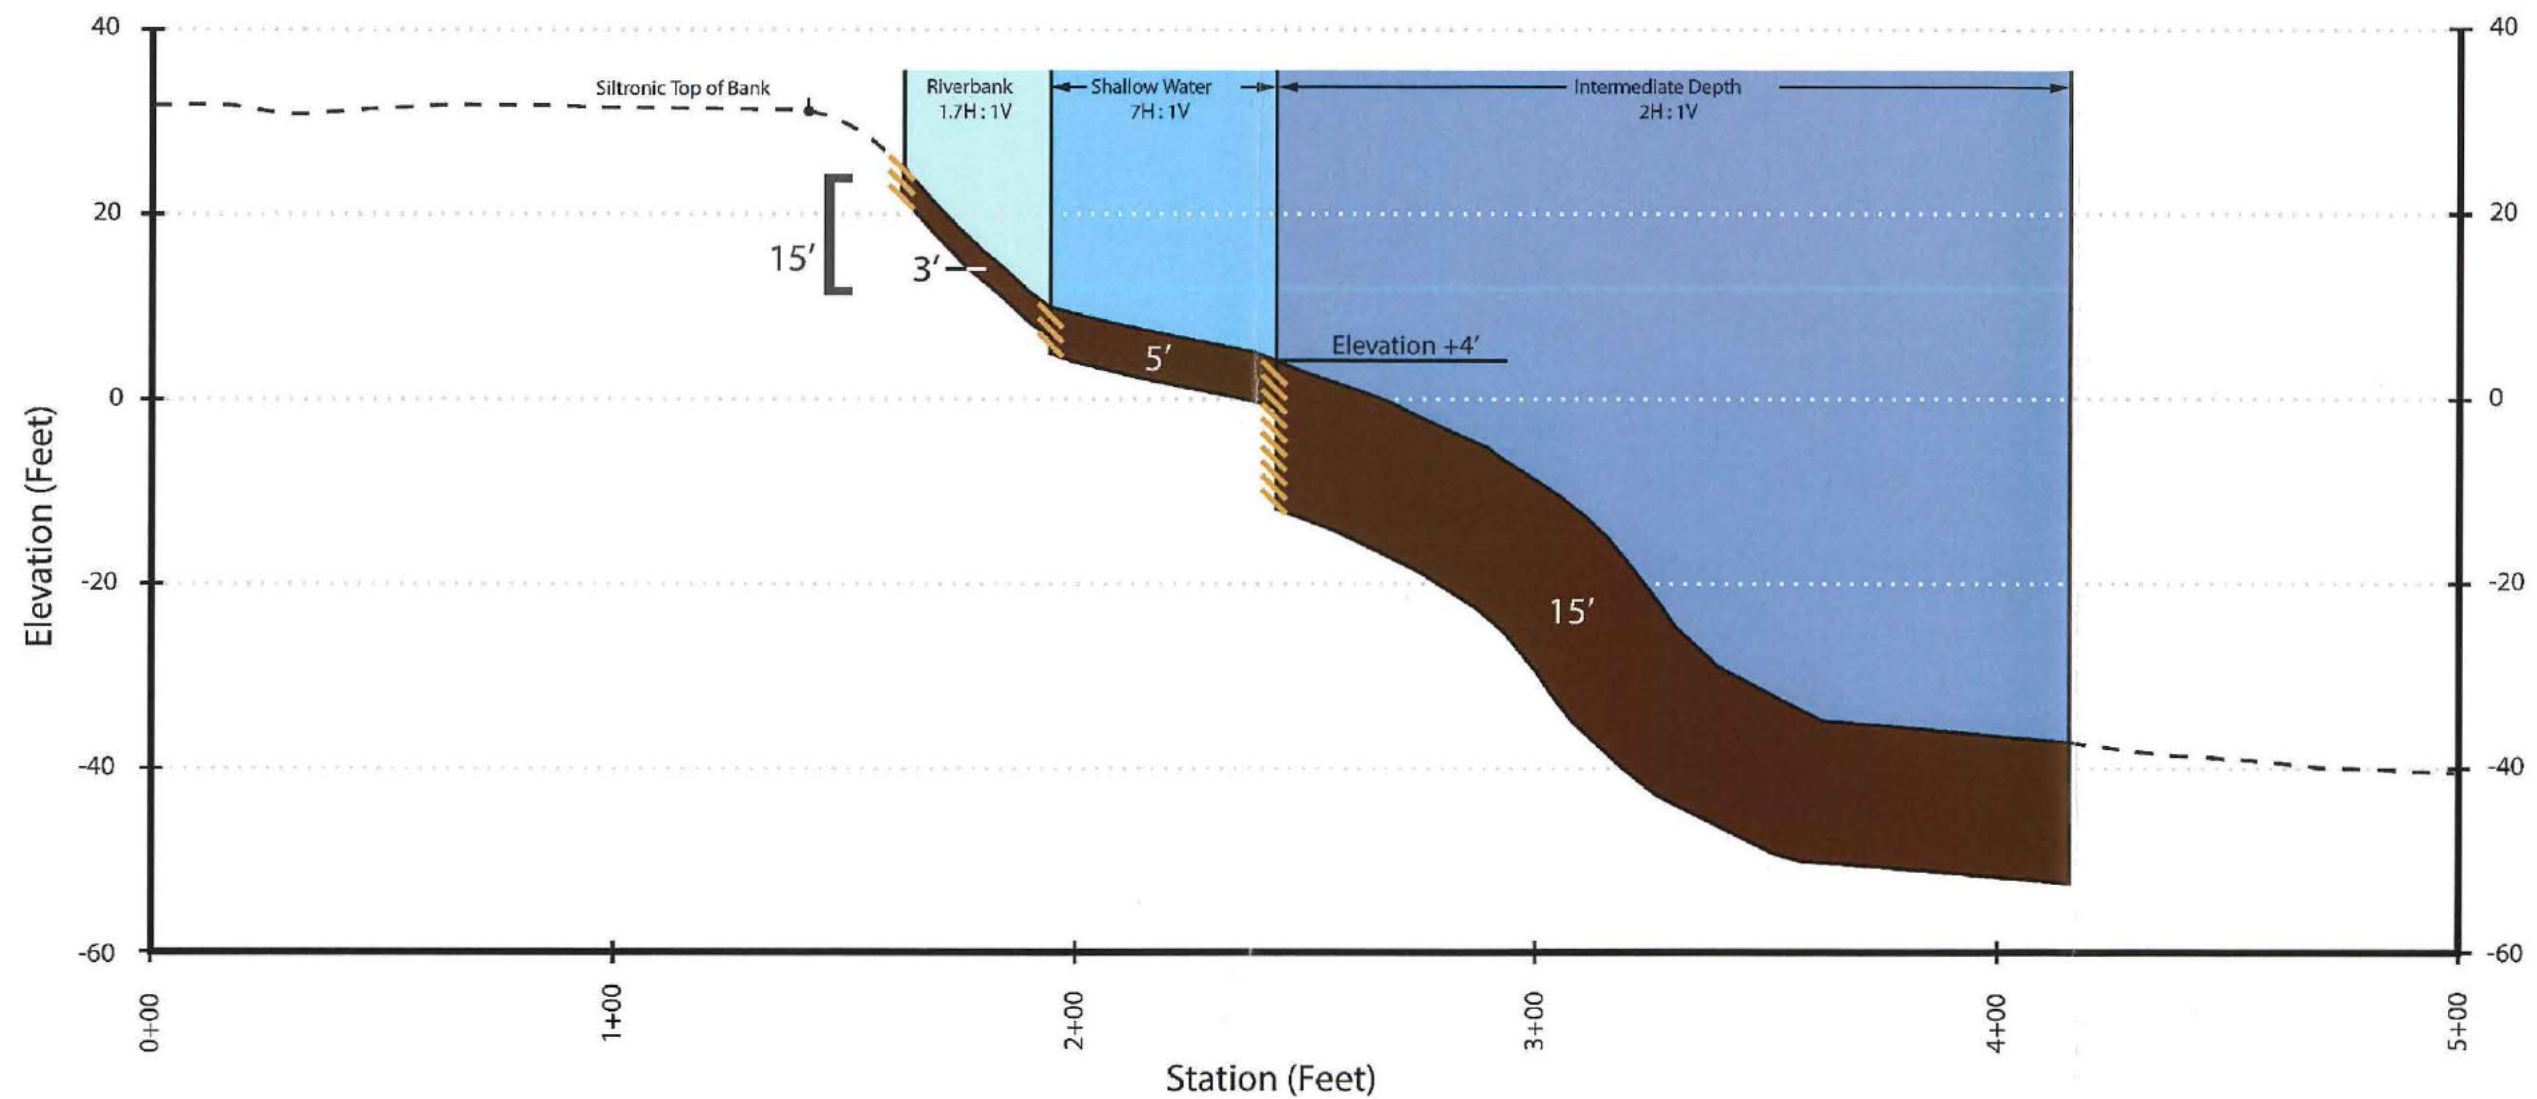
Figure 2
Riverbank and In-Water
Slope Zones

- EPA Proposed Maximum Excavation Depth
- Slope Destabilization Area

Siltronic is located along a very steep, heavily armored riverbank (see Figure 2), which would make for a very challenging investigation, assessment, and design process, should one be necessary. If contamination requiring remediation were to be identified, even limited removals in very small areas at the base of the Siltronic riverbank likely would pose significant geotechnical challenges and costs because of the steepness of the underlying riverbed and revetted bank, in addition to significant concerns regarding the foundations of structures and other infrastructure. EPA should therefore clearly account for site-specific riverbank remedy constraints in the ROD.

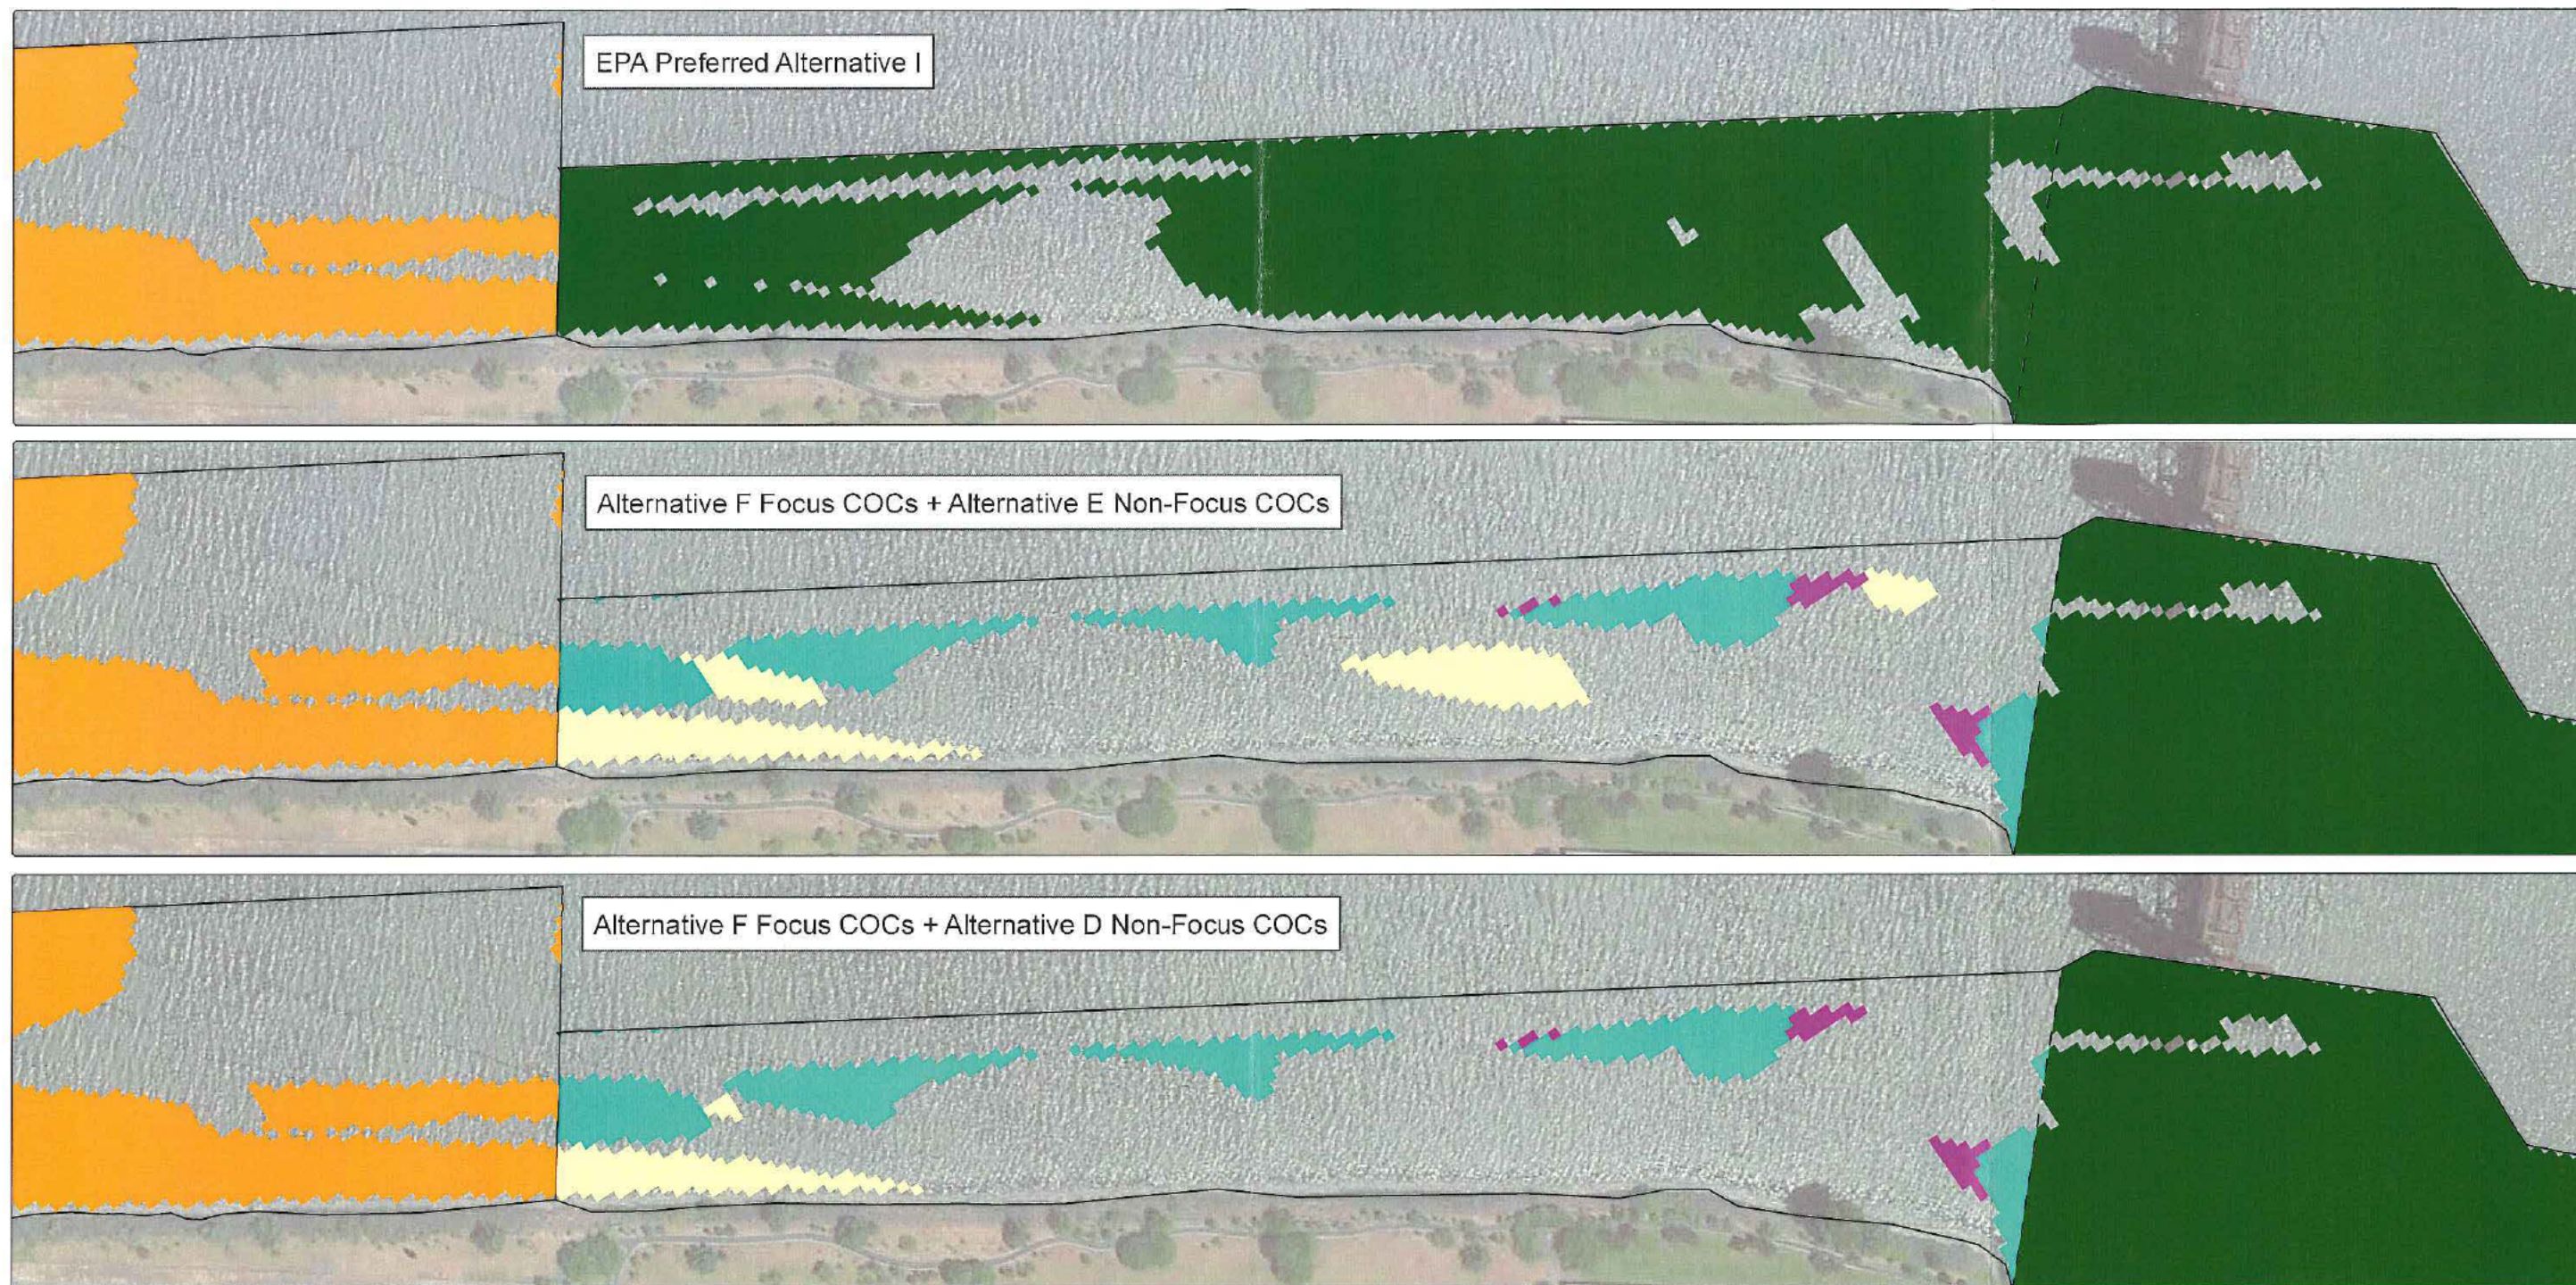
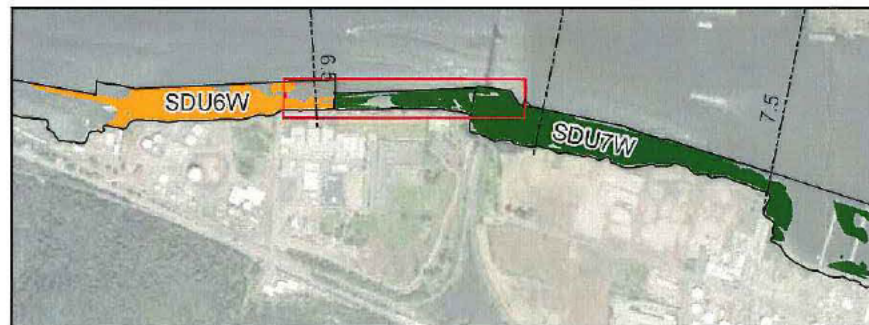
Figure 4
SDU7W Sediment Management Area (RM 6.6-6.8)
Siltronic Corporation
Portland, Oregon

- Notes:
1. Alternative I Areas shown as depicted in EPA's Proposed Plan 2016.
 2. See text for discussion of GIS methods.

- Legend**
- River Mile Tenths
 - SDU6W and SDU7W
 - Alternative D
 - Alternative F
 - Alternative F Dioxins, DDx
 - PAH
 - PCB (PTW)

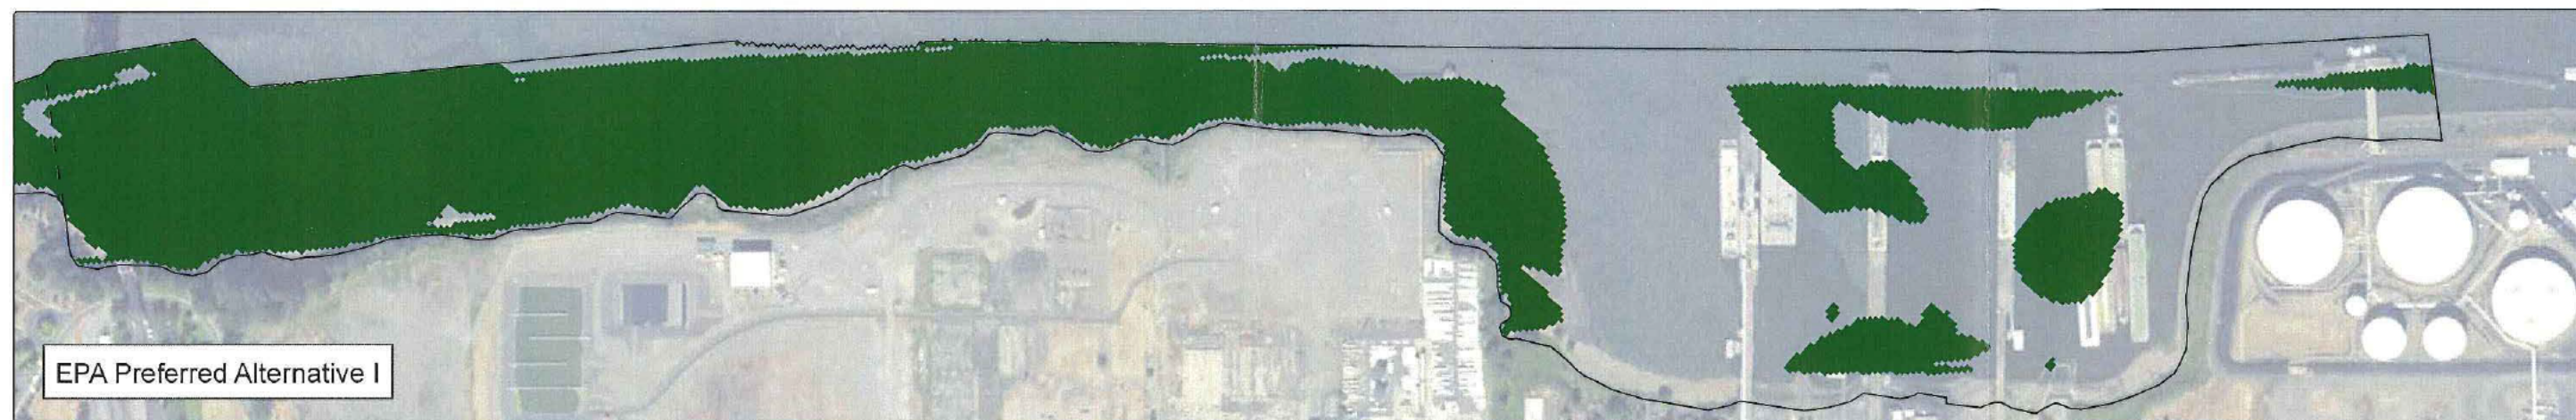
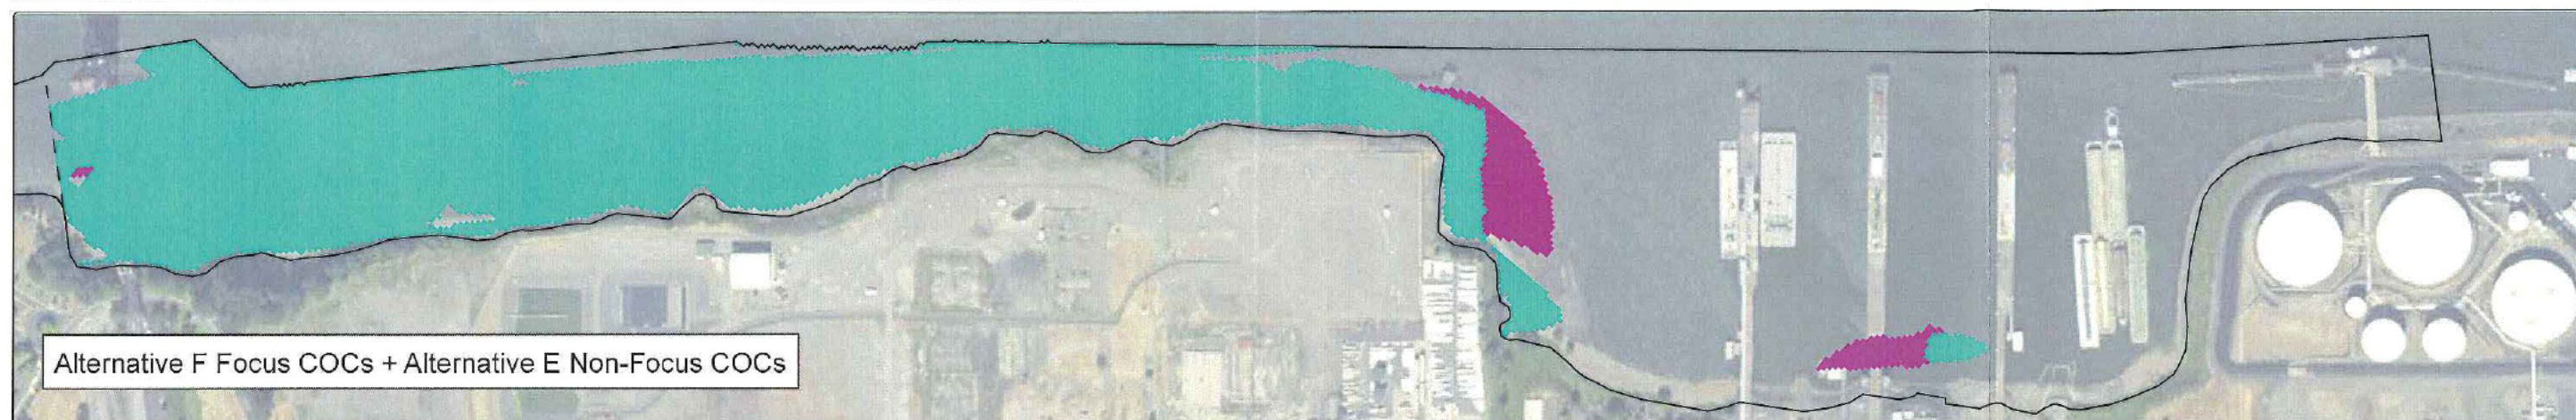
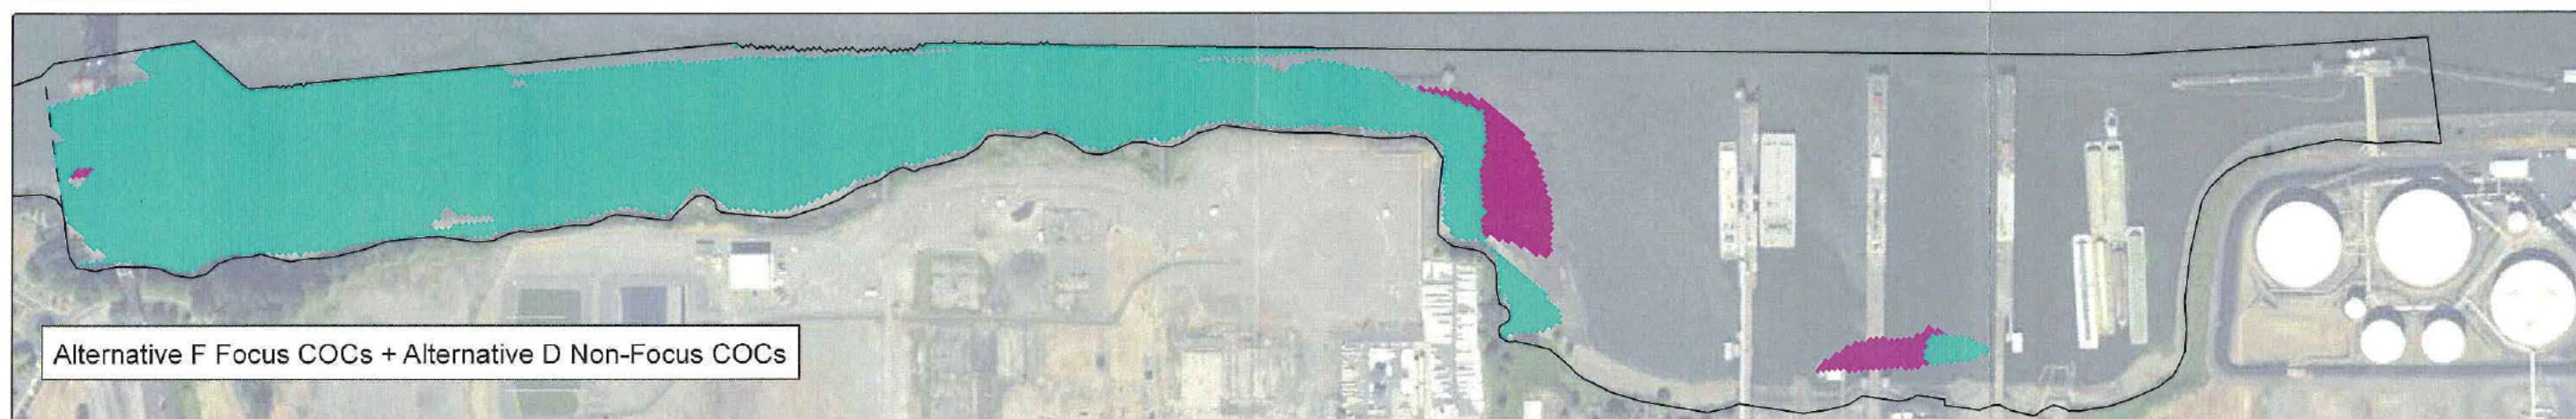
Figure 5
SDU7W Sediment Management Area (RM 6.9-7.8)
Siltronic Corporation
Portland, Oregon

Notes:
1. Alternative I Areas shown as depicted in EPA's Proposed Plan 2016.
2. See text for discussion of GIS methods.

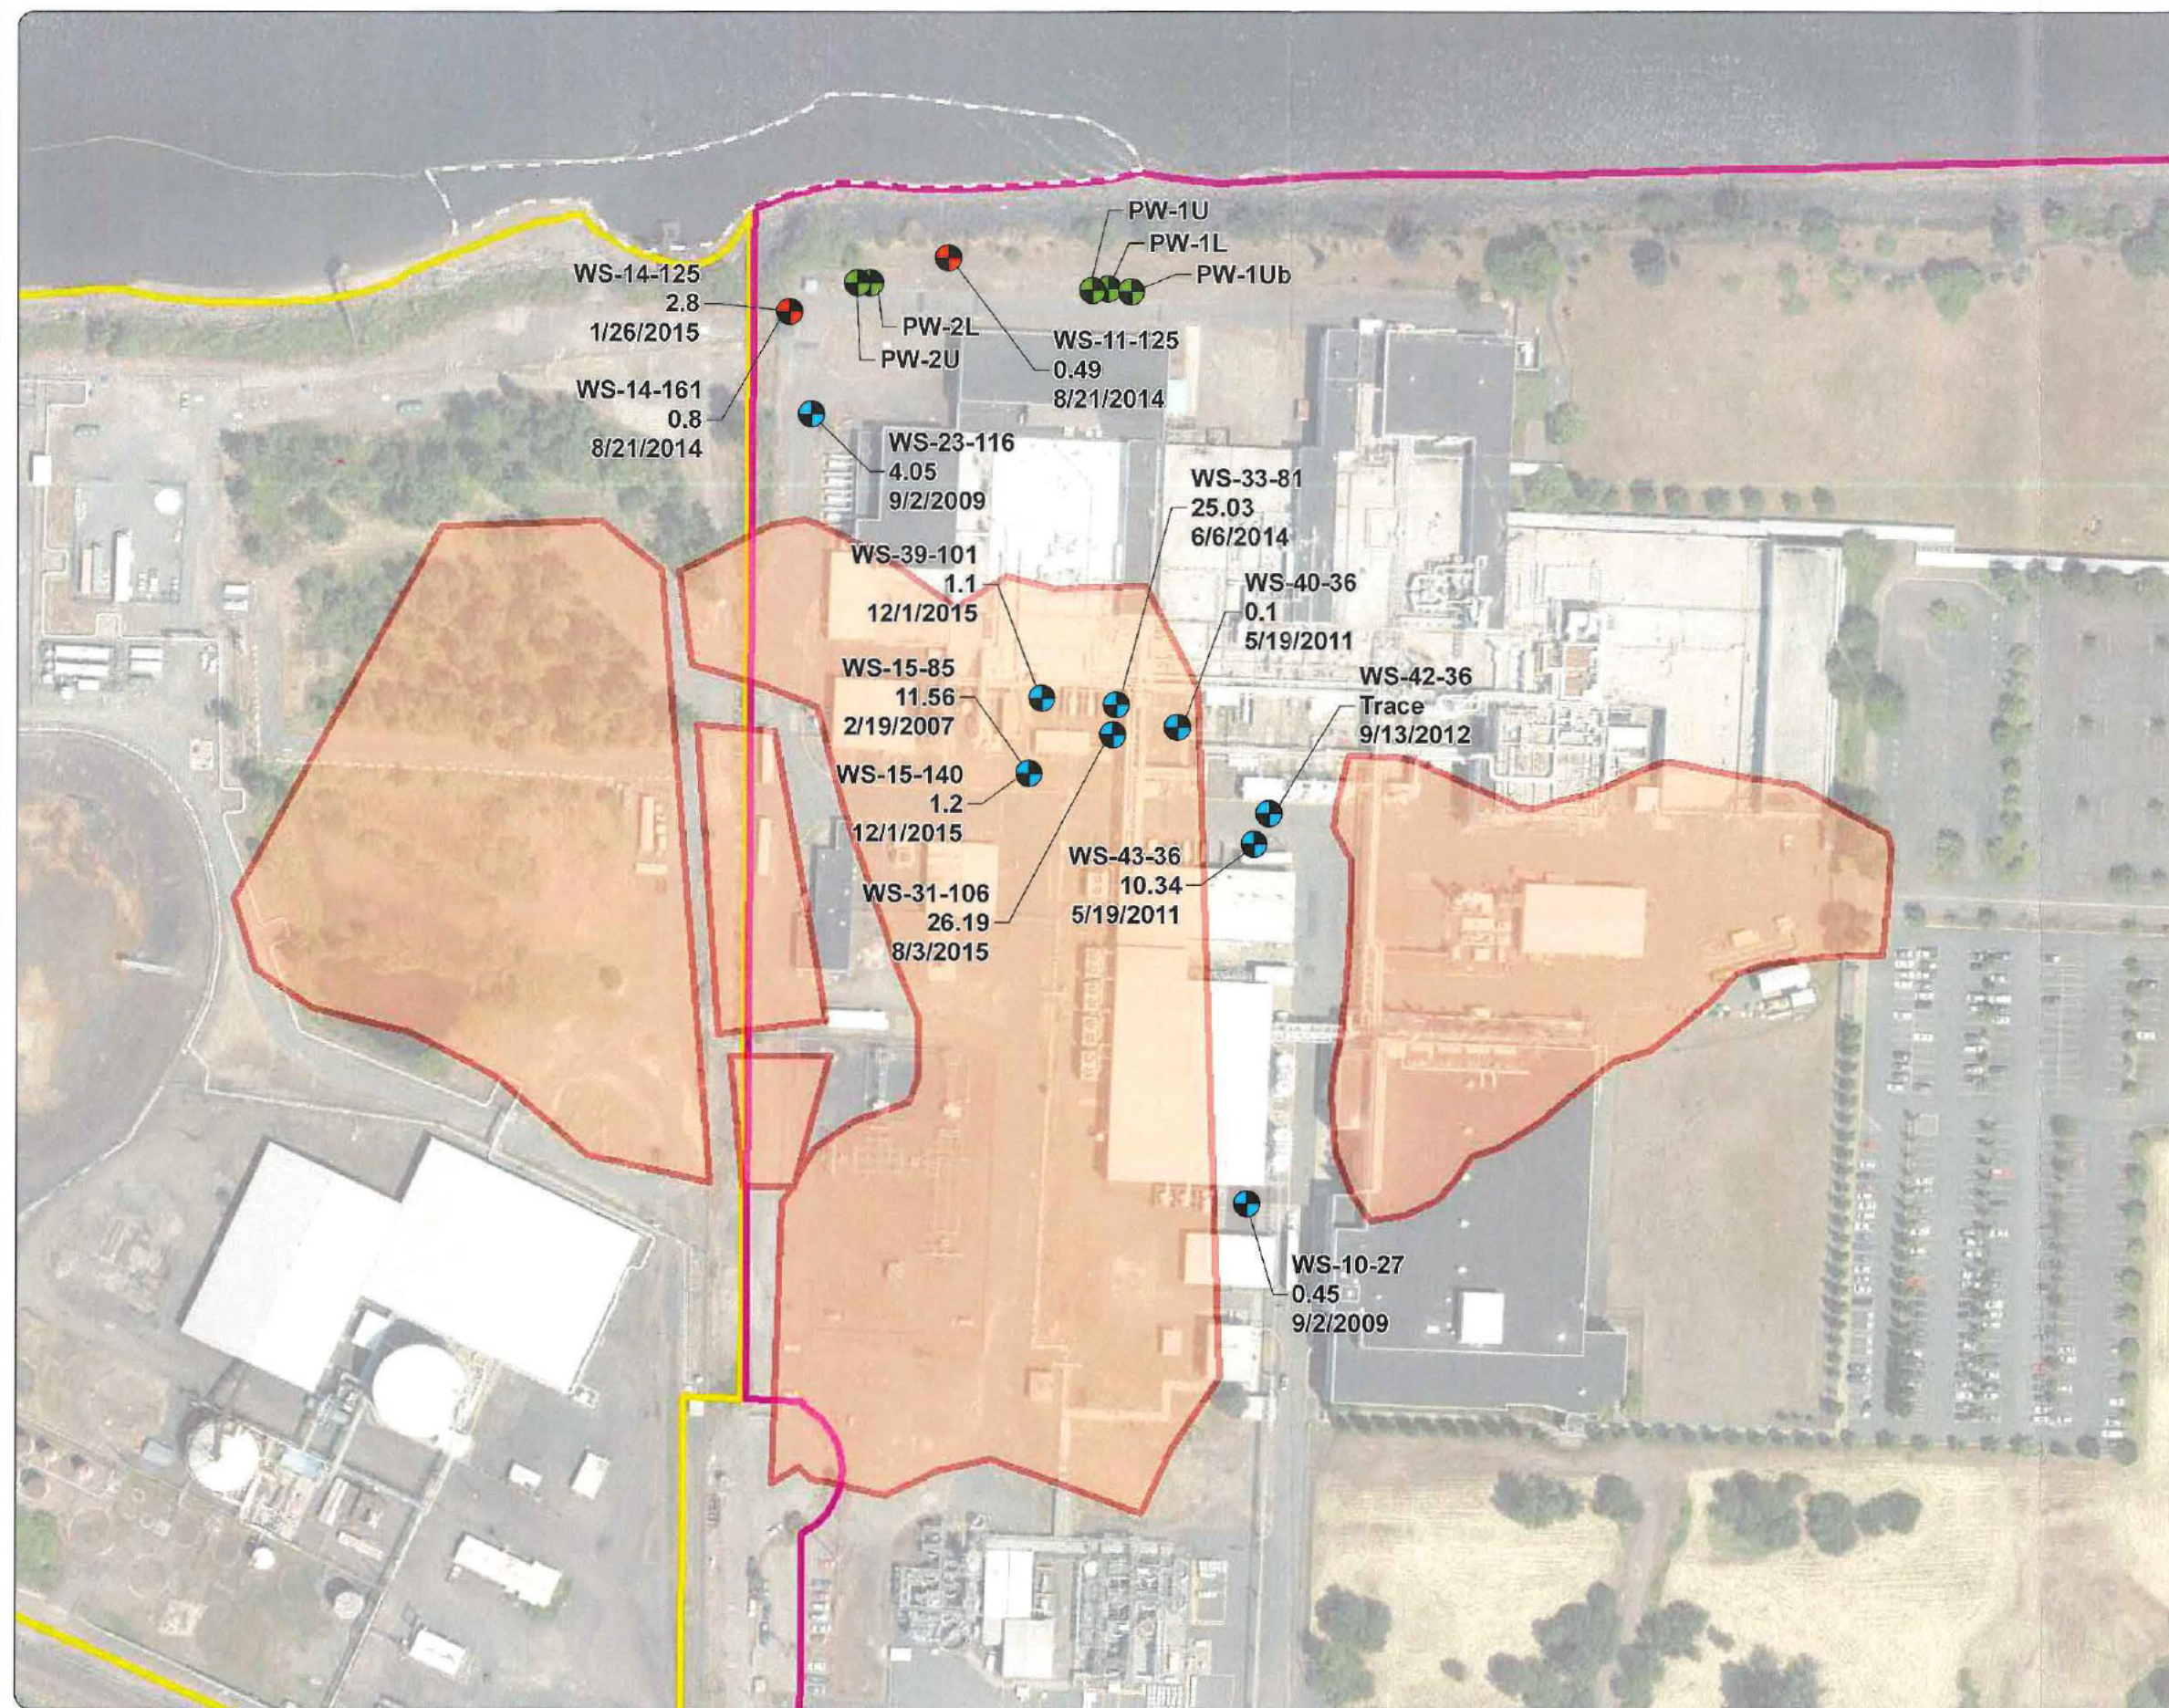
Figure 6
DNAPL Thickness
Measurements in
Wells Located on
Siltronic Property

WS-22-81 (Well ID)
25.03 (Max Observed DNAPL Thickness (feet))
6/6/2014 (Date of Max Observed DNAPL Thickness)

Today, light NAPL and dense NAPL (DNAPL) are present throughout the subsurface within and beyond the footprint of the former waste lagoon and effluent ponds. DNAPL has been observed entering wells screened as deep as 145 feet below ground surface.¹⁸ Figure 6 indicates the DNAPL thickness measured in various wells on the Siltronic property. The thickness levels fluctuate significantly over time, showing the dynamic state of the DNAPL (see Figure 7). NAPL is also present in the sediment offshore at depths of up to 16 feet below the mudline.¹⁹ NAPL continues to discharge to the Willamette River, and ebullition of NAPL to the surface water column is ongoing.

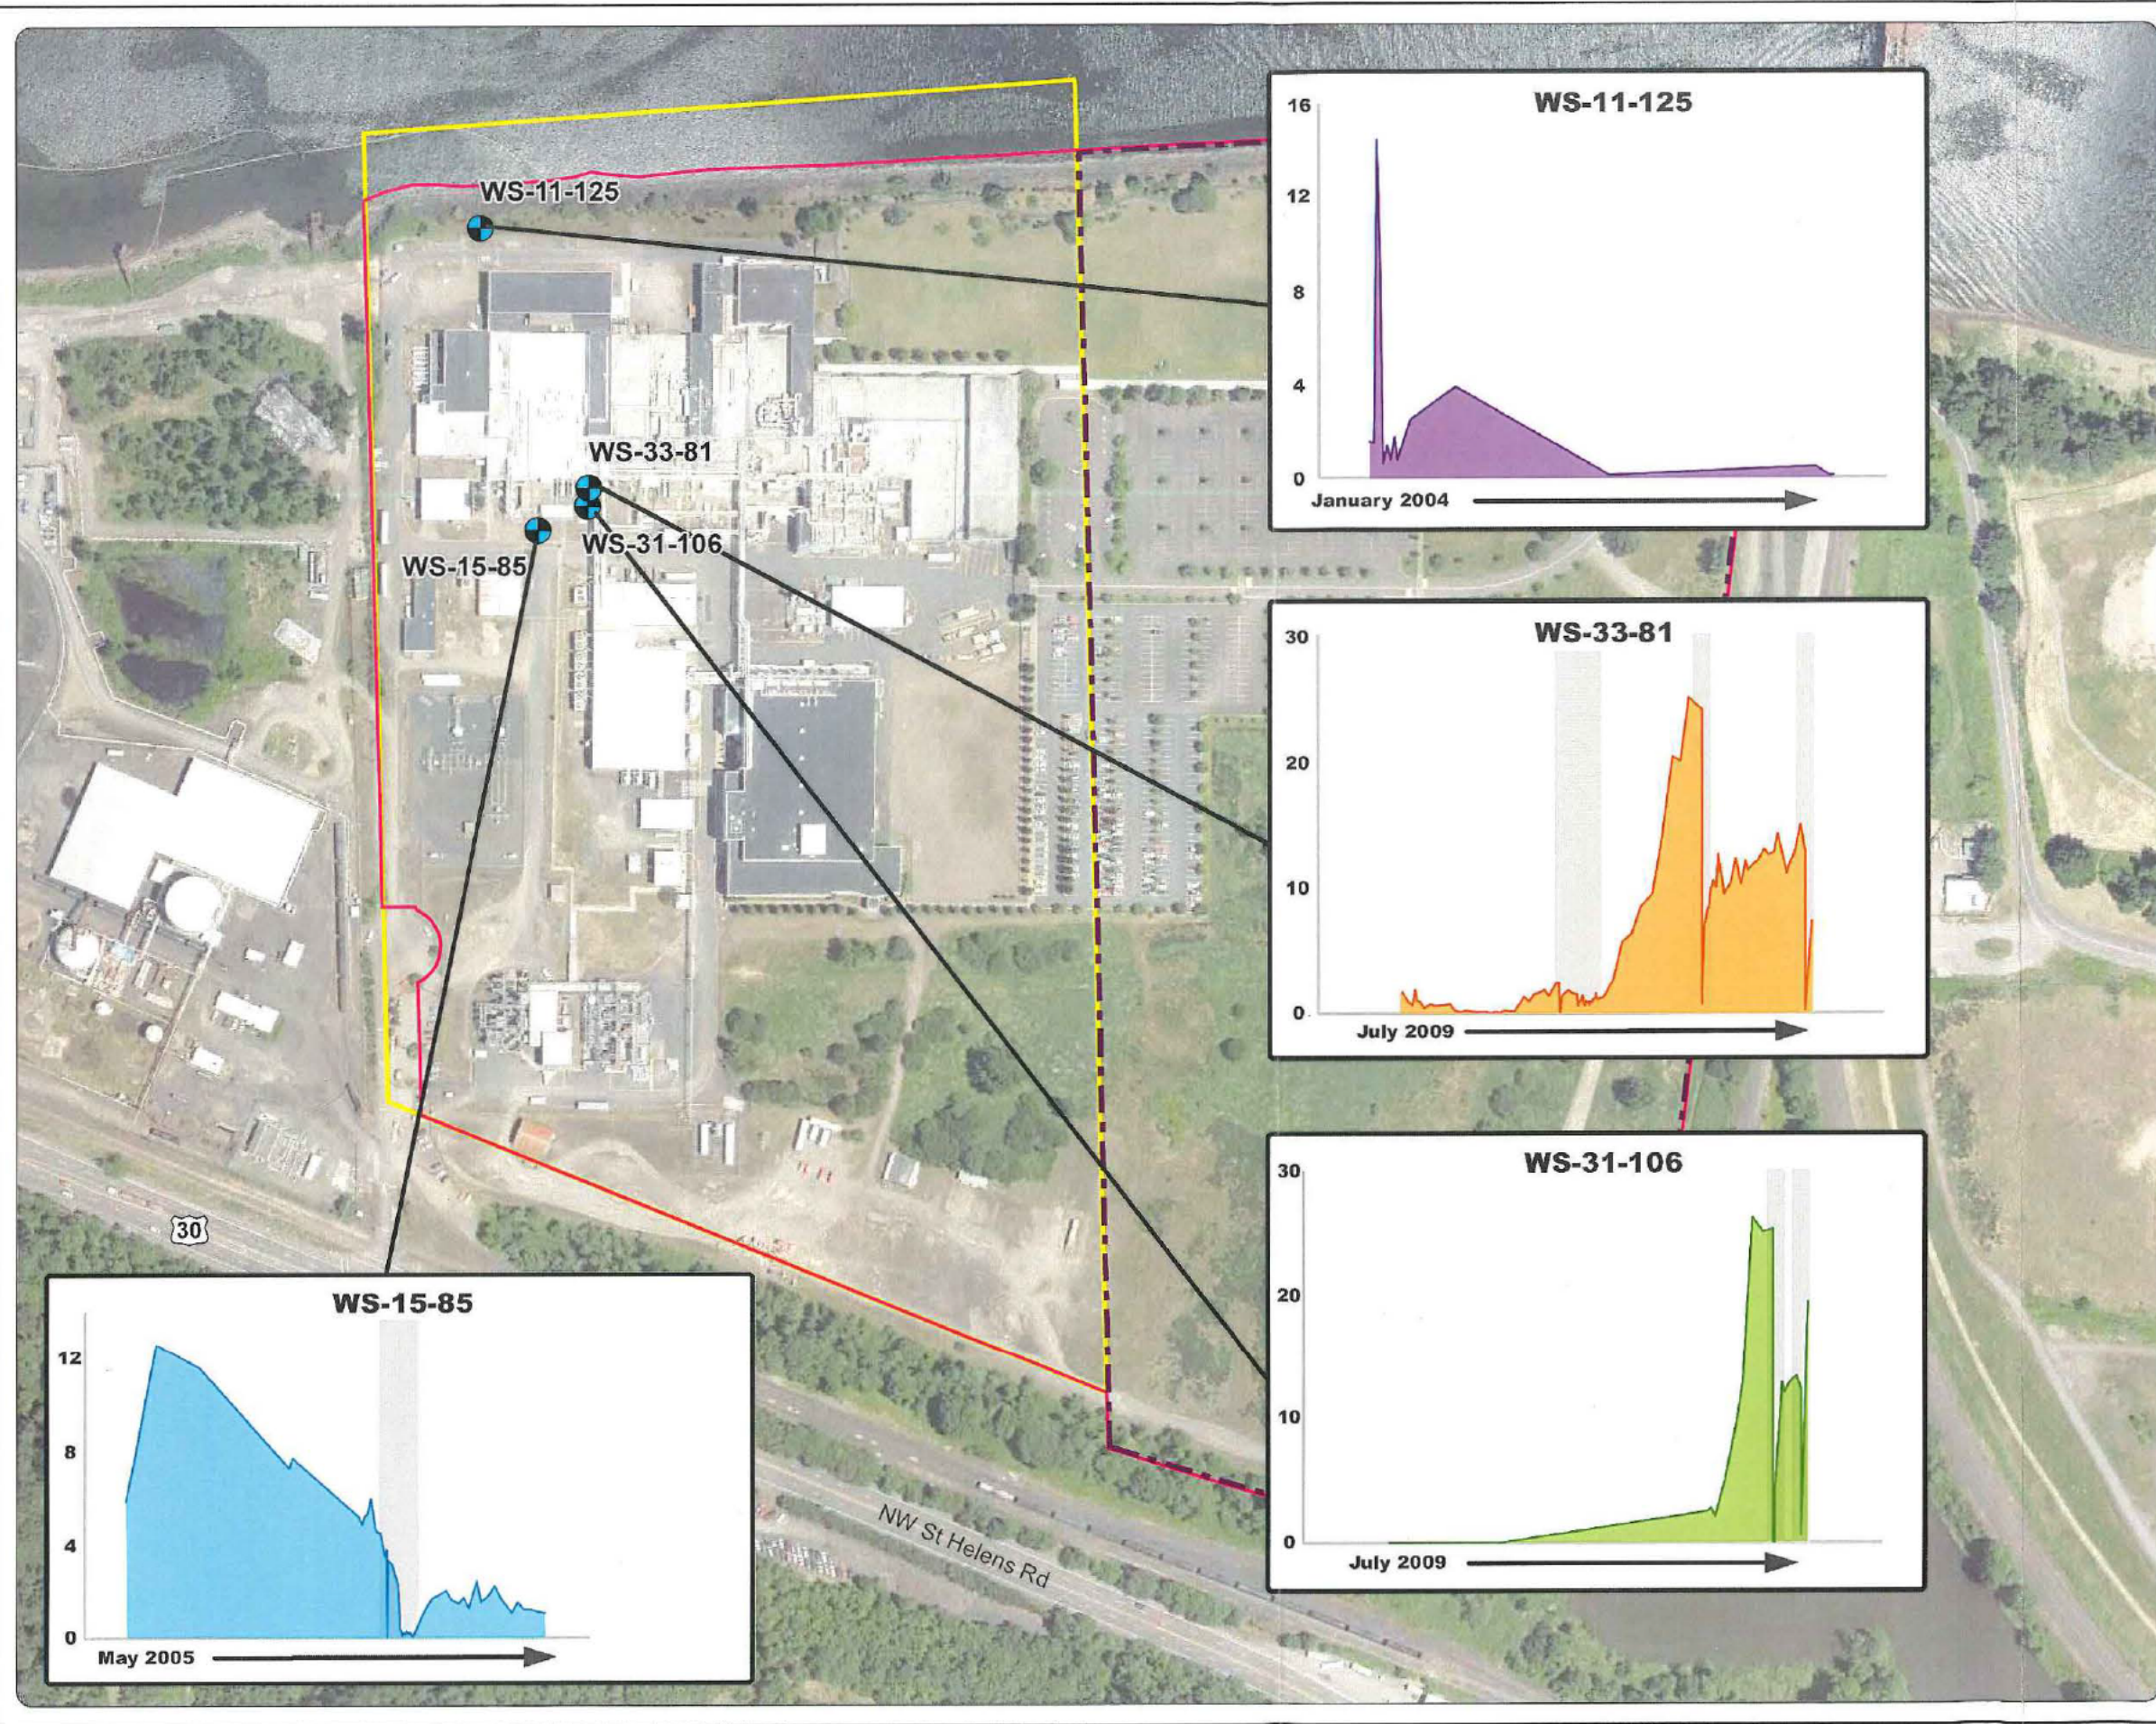
Figure 7
PG&C Waste DNAPL
Fluctuation Over Time

- Notes:
1. PG&C = Portland Gas & Coke
 2. DNAPL = dense nonaqueous-phase liquid.
